NAVAL AVIATION SAFETY CENTER

50
U. S. NAVAL AVIATION SAFETY CENTER
U. S. NAVAL AIR STATION
NORFOLK, VIRGINIA 23511

1. AIRCRAFT ACCIDENT BOARD APPOINTED BY CNAB, Third Naval District	2. SERIAL NO. WEEF 1-61A	3. DTG LOCAL OF MISHAP 061913H FEB	4. MODEL AIRCRAFT 0540	5. BUREAU NUMBER 56522
6. LOCATION OF MISHAP Peconic River Airport	7. TIME OF DAY RC Night	8. TIME IN FLIGHT 9 + 29	9. DAMAGE ALFA	10. FLIGHT CODE 2R2
11. VIA: CNAB Third Naval District CO. WEEF CNAB Eighth Naval District BUWPS	12. TYPE CLEARANCE IFR	13. AIRSPEED 100E	14. A/C WEIGHT 63,000 lbs.	15. ELEVATION AT TIME OF MISHAP 85
16. BRIEF DESCRIPTION OF MISHAP Collision, ground following visual W/O from ILS	17. TERRAIN Level	18. LAST MODEL, BUREAU, REPORTING CUSTODIAN AND DAMAGE CLASSIFICATION OF ANY OTHER A/C INVOLVED (Complete OPNAV Form 3750-1 for each A/C) None

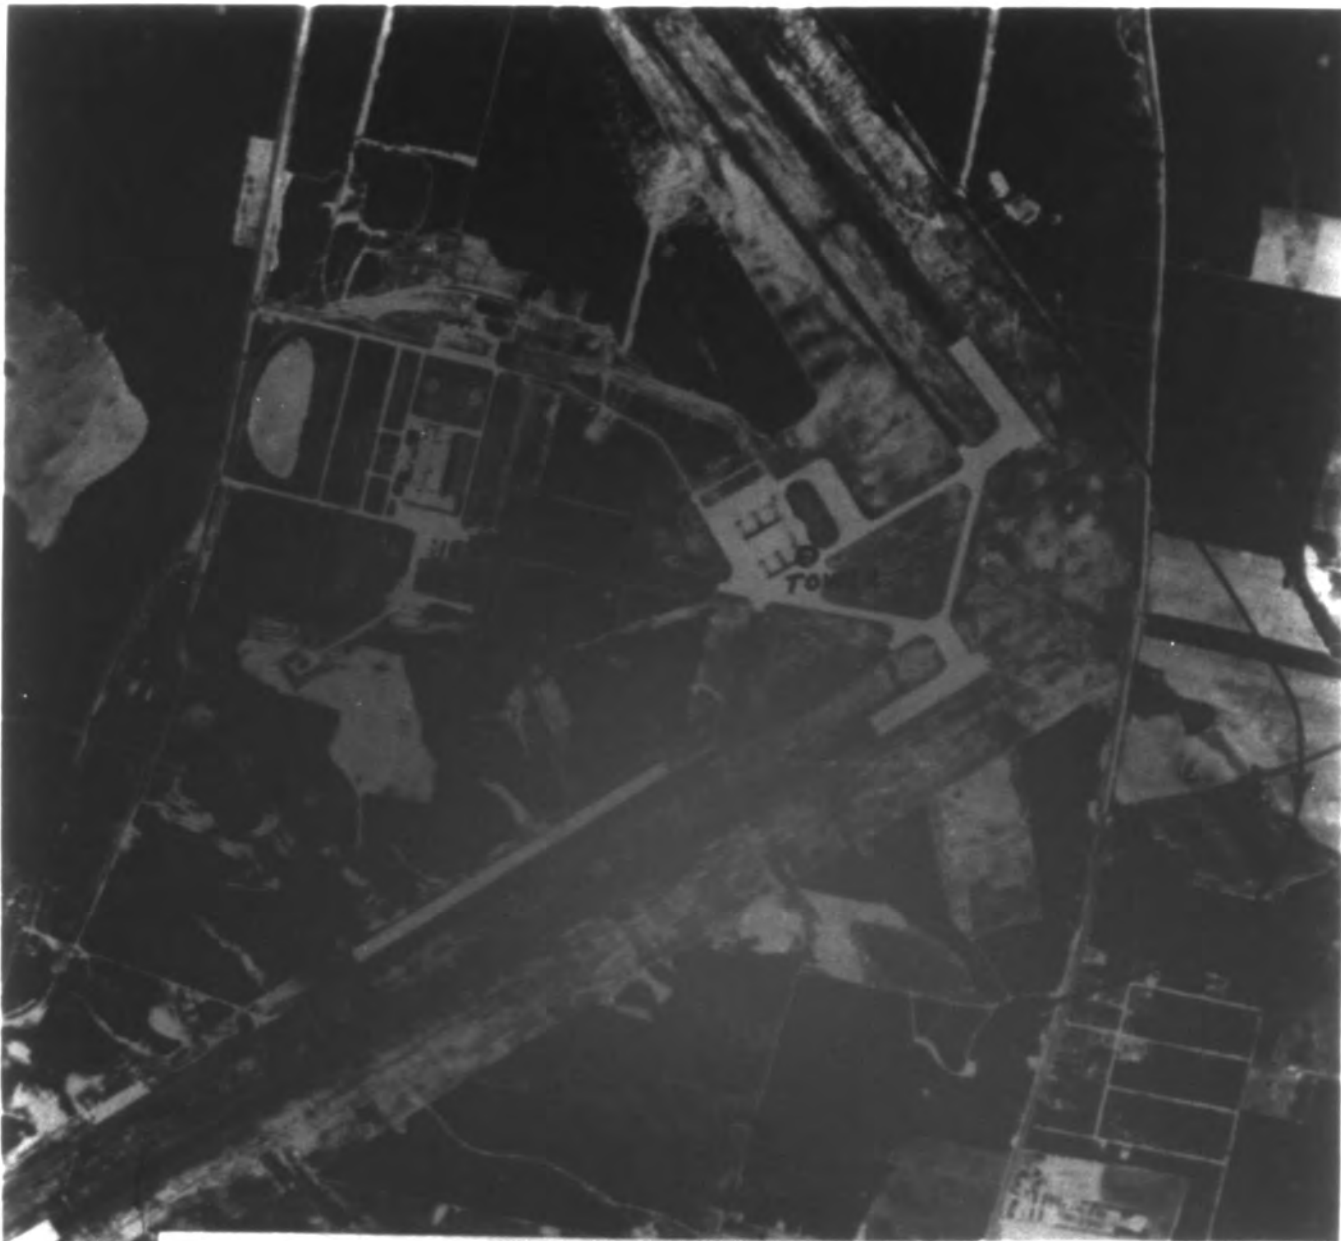
(2) Photographs show only wreckage in general and contain little or no detail as to the condition of various components, i.e., engines, propellers, flaps. The photograph indicating the flight path, enclosure (Y), lacks completeness. The probable route of the aircraft in relation to local radio aids, approximate positions, times, altitude, identification of runways, and location of key witnesses should be shown in order to better understand the narrative of the accident.

Enclosure (Y) to NWEF AAR 1-64A showing probable flight path prior to impact
SPECIAL HANDLING REQUIRED IN ACCORDANCE WITH SEC I, OPNAVINST 3750.6K
